## Substantial Changes Follow 2-Year Dormancy of Wingfield Pines Abandoned Mine Drainage Remediation System

**By Garrett Struble** Published December 10, 2020 D.U.Quark 2020. Volume 5 (Issue 1) pgs. 23-40 Peer Reviewed

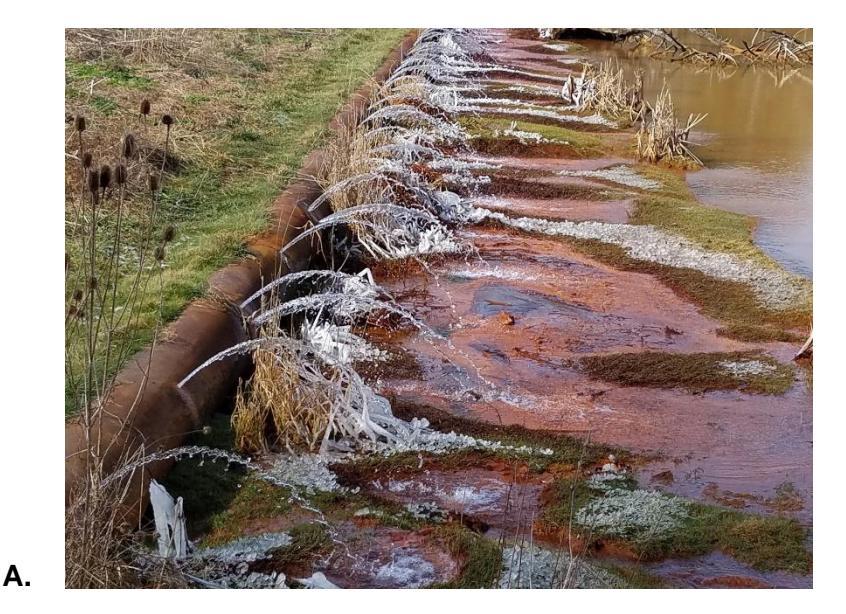
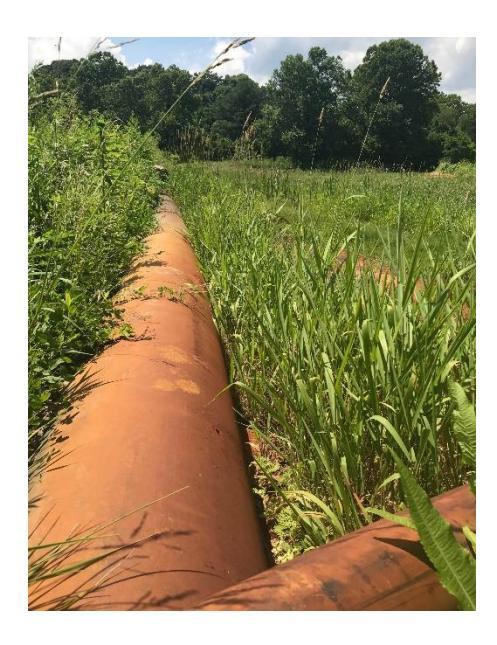
On November 6, 2017, ALT staff at Wingfield Pines noticed that the system's fountain pipe was no longer running **(Figure 1A&B)**. The fountain pipe usually feeds the system and exposes ferrous iron (Fe<sup>2+</sup>) to oxygen to form ferric (Fe<sup>3+</sup>) iron precipitants<sup>1</sup>. Further investigation attributed the system's failure to a major breach in the mine cavern, causing the AMD to bypass the system<sup>1</sup>. ALT staff suggested that multiple flash flood events in the McLaughlin Run watershed around the time of the blowout likely acted to catalyze the geologic event<sup>1.</sup> Immediately after the blowout was discovered, ALT staff began their proposal to contain AMD and repair the system<sup>1</sup>. Repair of the system would prove difficult, however, due to the magnitude and location of the blowout.

**Figure 1. Fountain Pipe which Feeds AMD System. (A)** The fountain pipe which feeds the passive remediation system and oxidizes ferrous iron in AMD effluent is shown before the system's failure in November 2017. Photo taken 17 February 2017 by Michelle Valkanas, Ph.D. candidate; Duquesne University. (B) After the system's failure, the fountain pipe which feeds pond 1 stopped flowing. The abundance of plant life which appeared in the system during the ~2-year repair is shown. Photo taken 26 June 2019 by Garrett Struble.

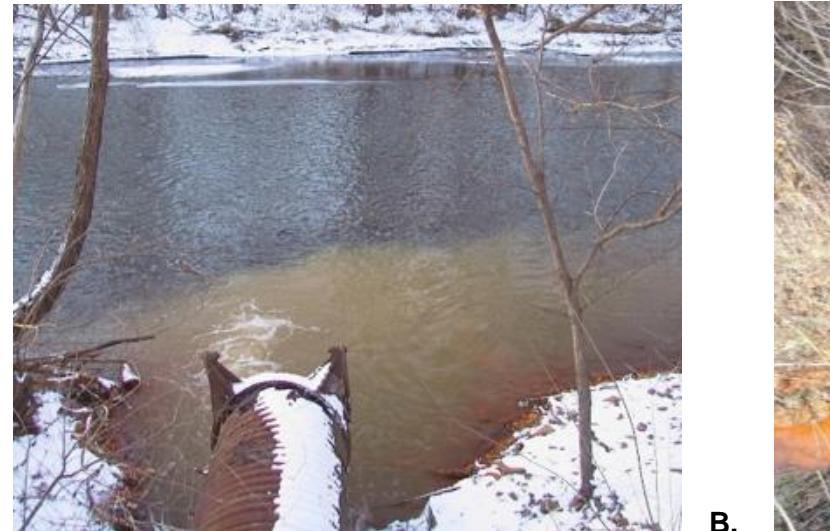
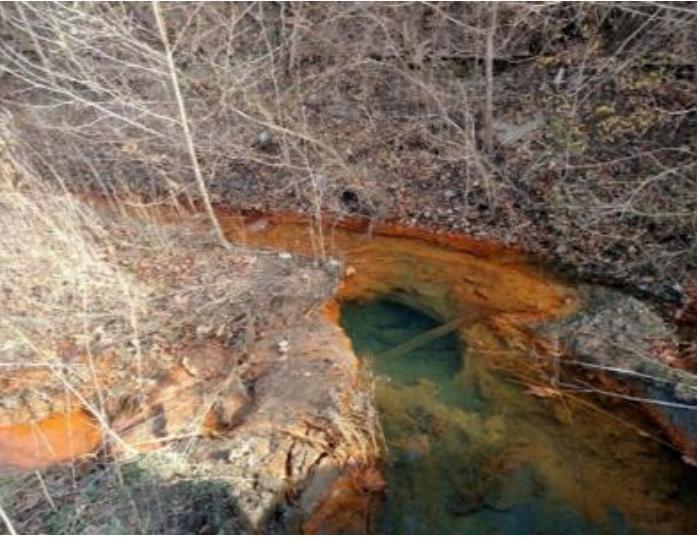
Following the major rupture to the mine cavern in November 2017, AMD bypassed the 20-acre passive remediation system, flowing directly into Chartiers Creek at rates of ~2,000 gallons/min (**Figure 2A&B**)<sup>1</sup>. Due to the nature of the sub-surface fracture, the multi-step repair took nearly 2 years to complete—leaving the system dormant. Until the system's re-opening in September 2019, iron-rich AMD flowed directly into Chartiers Creek as it did pre-2009 (**Figure 2B**)<sup>1</sup>. Multiple flooding and severe weather events, which increased in intensity in 2018, paired with the effluent of the AMD breach caused the PVC effluent pipe to become eroded. The result was an iron-laden stream bed connecting the final holding pond directly to Chartiers Creek

**Figure 2. Mine Breach Photographed Shortly after Rupture. (A)** Non-remediated AMD can be seen flowing into Chartiers Creek before the system's installation. Wingfield Pines AMD discharge has an orange color due to high iron content. Photo taken 2008. **(B)** The blowout hole which caused the breach of the passive remediation system spews AMD. Photo taken 6 November 2017. Photos by Emilie Rzotkiewicz, Vice President of Land Resources; Allegheny Land Trust

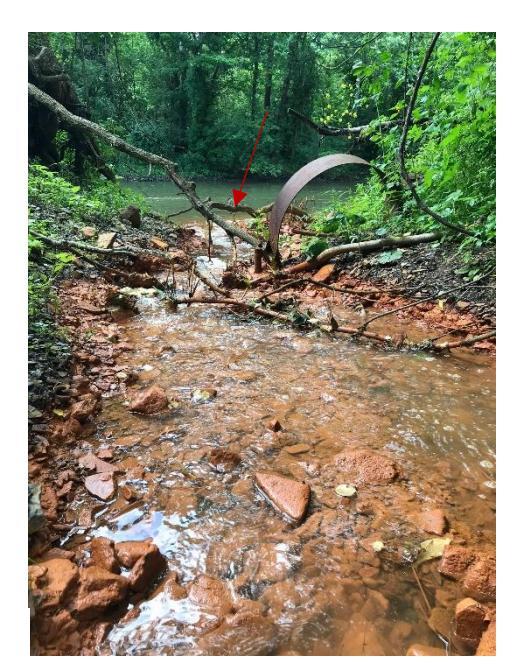
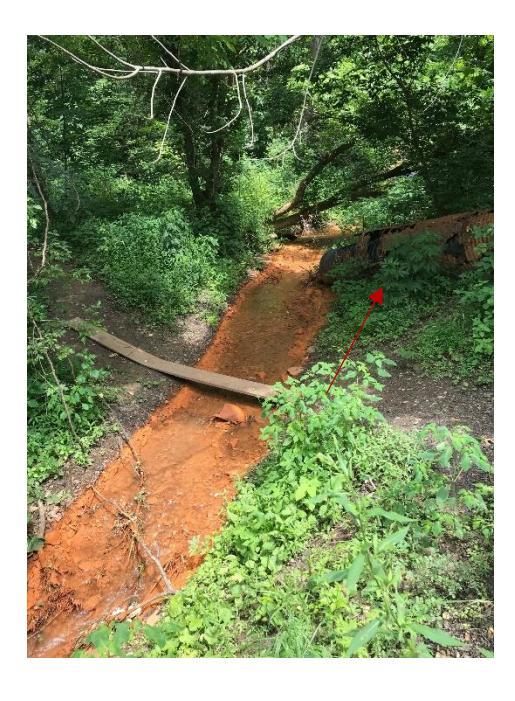
(**Figure 3 A&B**). Failure of the passive coal mine remediation system at Wingfield Pines, followed by its lengthy ~2-year construction, illustrate the long-lasting effects of previous unsustainable land use.

**Figure 3. Discharge of AMD into Chartiers Creek After System Breach. (A)** Multiple flooding and severe weather events paired with the effluent of the AMD breach led to a wash out of the system's effluent pipe, which previously fed Chartiers Creek (red arrow). **(B)** Debris from the remnants of a land bridge with sub-surface PVC drainage pipe can be seen scattered on the right side of the riverbank (red arrow). Photos taken 26 June 2019 by Garrett Struble.

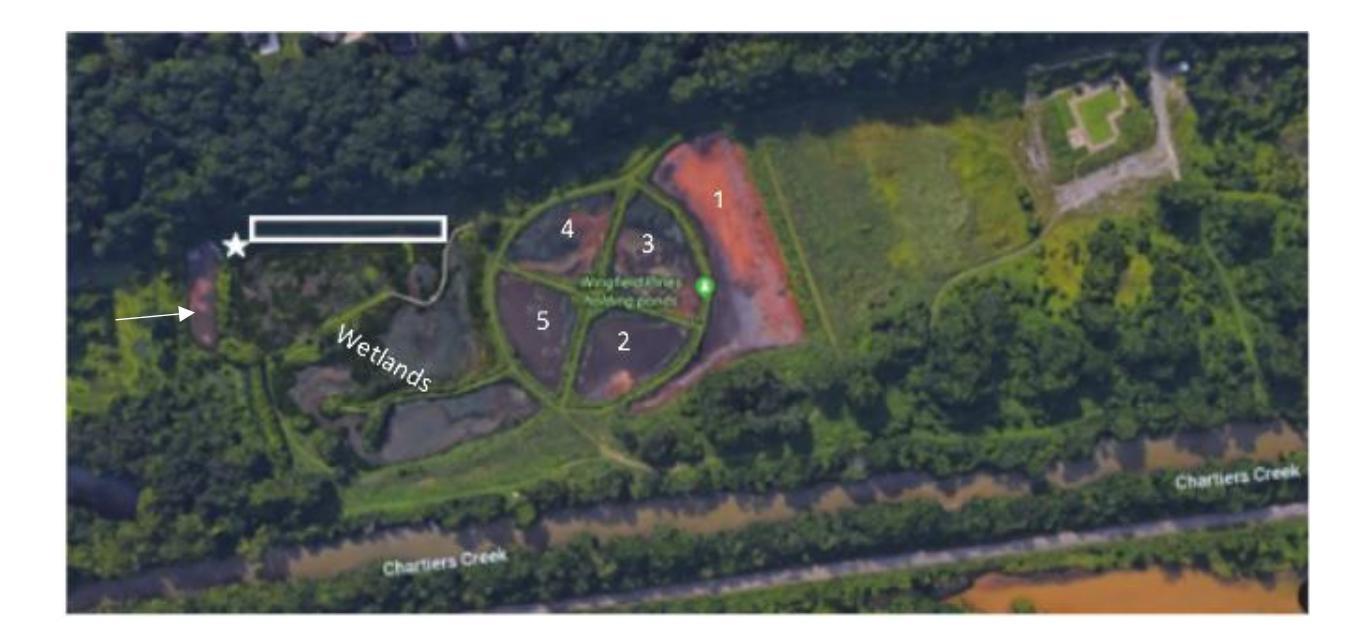
**Figure 4. Location of Mine Cavern Breach at Wingfield Pines.** The surface location of the mine breach is labelled with a star icon. AMD flowed into a small retention pond (white arrow) that drains into Chartiers Creek after the system's wetlands. The portion of the wetlands removed to allow access to the blowout is denoted with a white rectangle. Locations of the ponds and wetlands are labelled. Image retrieved from Google Earth on 30 November 2019.

Repair of the system occurred in several stages: redirecting mine flow, installing an emergency pump, drilling around the fracture and subsequently sealing with a combination of polyurethane foam (Sub technical) and <u>cement</u> (Howard Cement)<sup>6-7</sup>. The mine fracture occurred on the high wall just before the discharge of the system's wetland into a final holding pond (**Figure 4**) before meeting Chartiers Creek. Due to the location of the fracture, a portion of the wetlands bordering the system was replaced with limestone gravel in order to allow the passage of construction vehicles (**Figure 4**). The disturbed portion of the wetlands does not receive AMD and was primarily composed of *Impatiens capensis* (spotted jewel weed) and *Sparganium americanum* (bur reed).

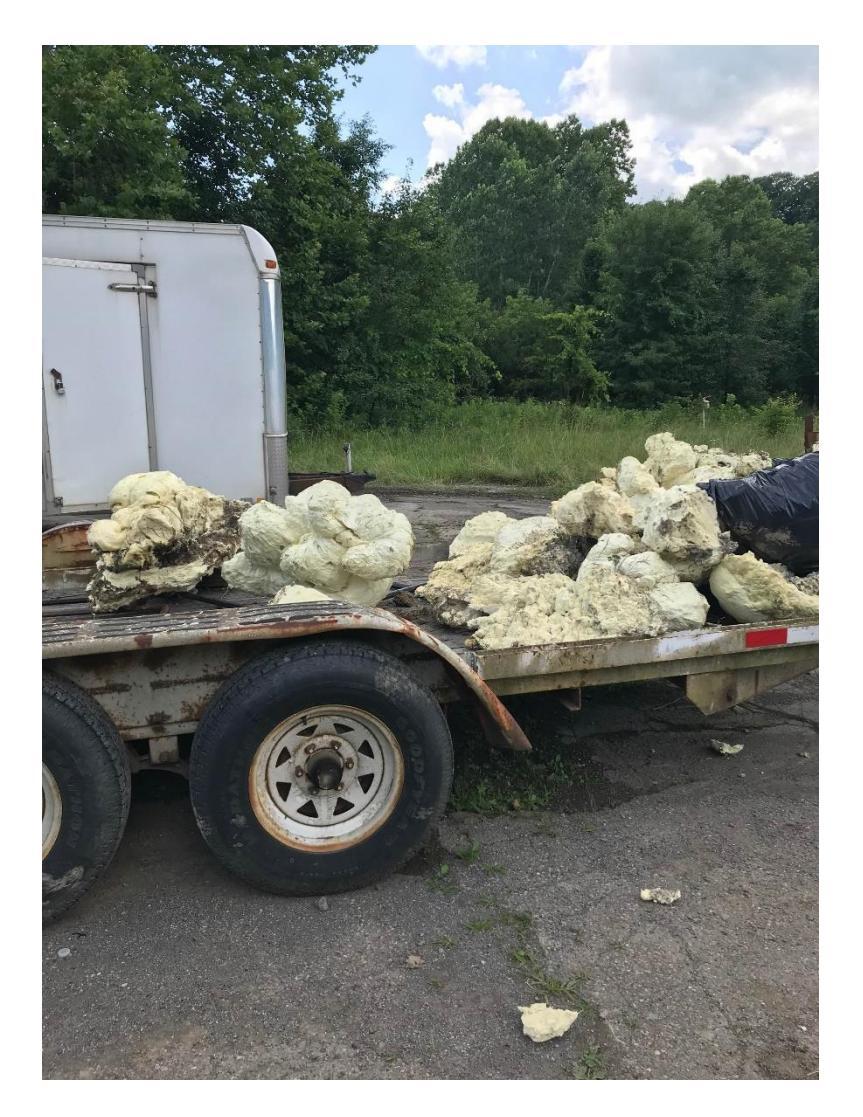
**Figure 5. Temporary Foam Sealant Used in Repair.** Excess foam sealant used to seal the AMD breach can be seen on a trailer before removal from the property. Photo taken 26 June 2019 by Garrett Struble.

To achieve this feat, several staging areas and heavy-duty construction equipment were required to drill access holes to the mine cavern breach, install underground fail-safe/redirecting piping, and inject temporary sealant. ALT hired independent contractors Sub-Technical and Howard Cement to inject foam sealant and cement, respectively. Sub-Technical originally estimated that 600lbs of polyurethane foam sealant was needed to seal the mine blowout. Due to the unexpected extent of the fracture, 11,000lbs of polyurethane was actually required to produce the seal. Excess foam sealant, which overflowed from injection holes, is pictured in **Figure 5**.

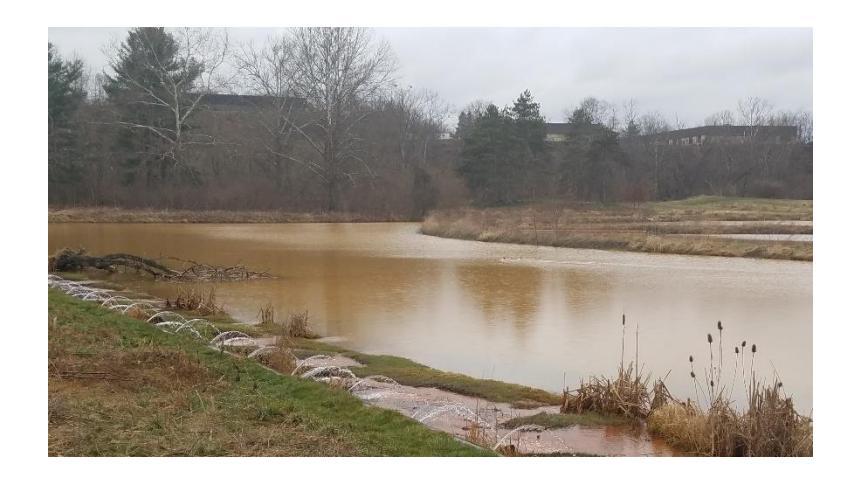
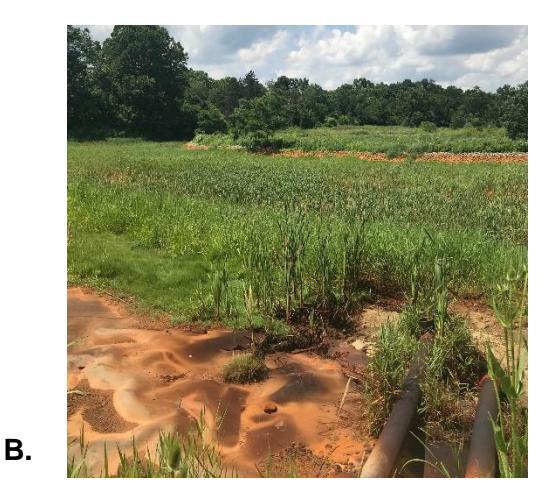
**Figure 6. Pond 1 Before and After System Failure**. **(A)**. Pond 1 photographed before the system's failure shows functional fountain pipe and absence of plant-life. Photo taken 27 February 2017 by Michelle Valkanas, Ph.D. candidate; Duquesne University. **(B)** Pond 1 photographed during the system's repair shows abundance of plant cover in dry ponds. Photo taken 26 June 2019 by Garrett Struble.

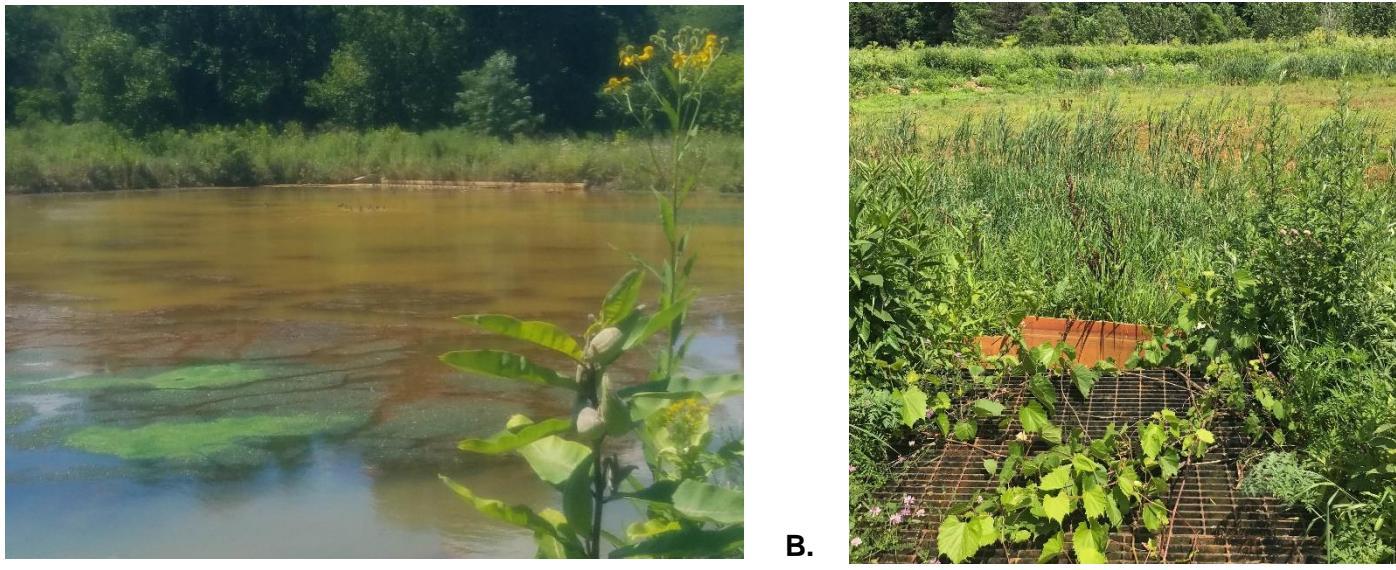
**Figure 7. Pond 2 Before and After System Failure. (A)** Pond 2 photographed before the system's failure shows absence of plant-life. Photo taken 8 August 2017 by Michelle Valkanas, Ph.D. candidate; Duquesne University. **(B)** Pond 2 photographed during the system's repair shows abundance of plant cover in dry ponds. Photo taken 26 June 2019 by Garrett Struble

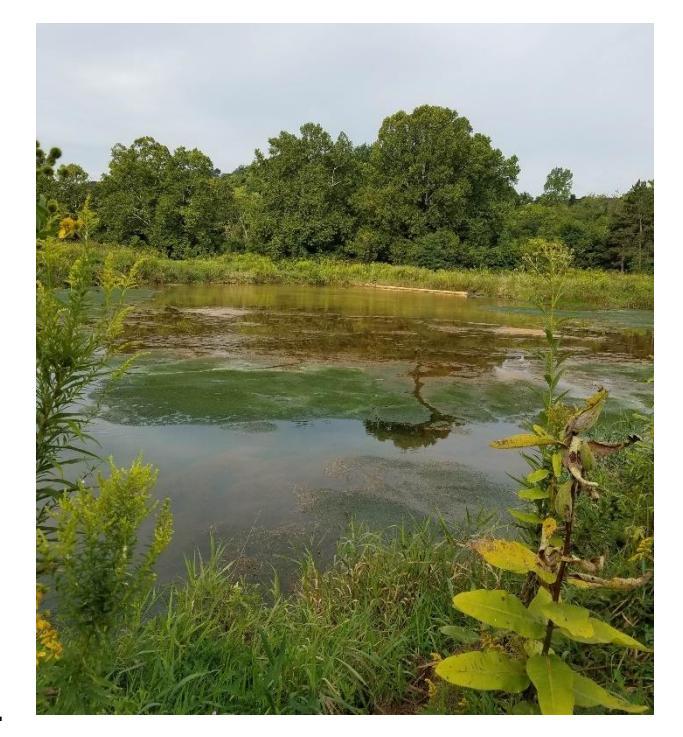
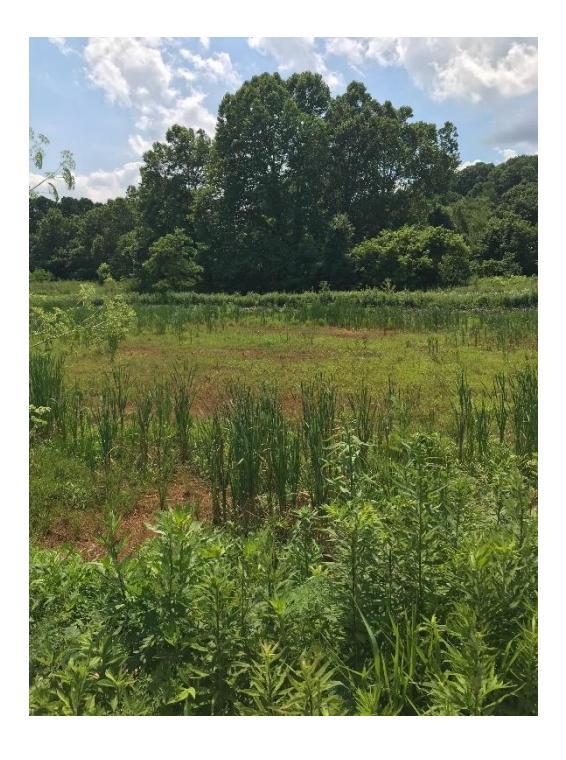
**Figure 8. Pond 3 Before and After System Failure. (A)** Pond 3 photographed before the system's failure shows absence of plant-life. Photo taken 29 August 2017 by Michelle Valkanas, Ph.D. candidate; Duquesne University. (**B**) Pond 3 photographed during the system's repair shows abundance of plant cover in dry ponds. Photo taken 26 June 2019 by Garrett Struble

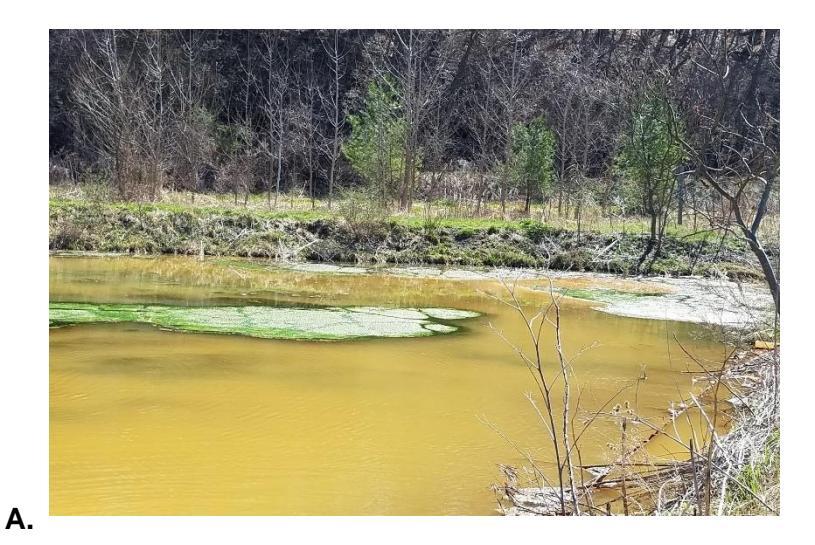
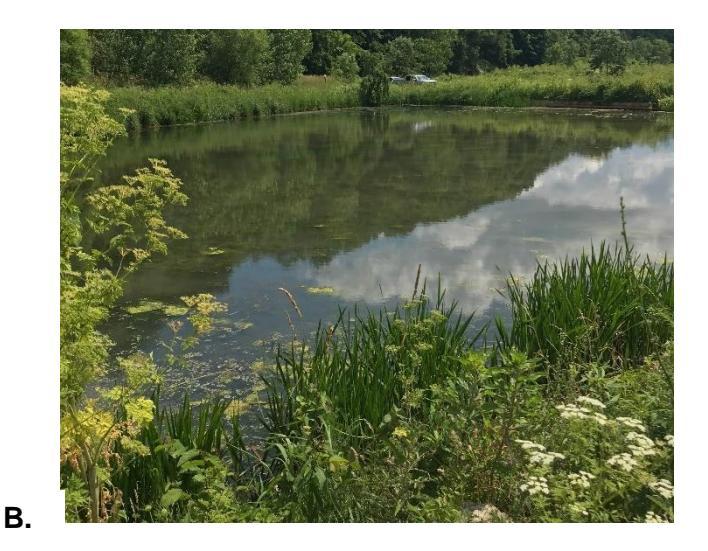
**Figure 9. Pond 4 Before and After System Failure. (A)** Pond 4 photographed before the system's failure shows absence of plant-life. Photo taken 29 March 2017 by Michelle Valkanas, Ph.D. candidate; Duquesne University. (**B**) Pond 4 photographed during the system's repair shows maintained absence of plant cover due to maintained fill. Photo taken 26 June 2019 by Garrett Struble

Pond 4 remained clear of vegetation except around its shore as a result of remaining filled during the system's repair (**Figure 9A**). The impact that these changes have had on the system from a physical standpoint alone will likely prove significant. During the ~2-year dormancy, pond 4 was also exposed to vastly different redox conditions than ponds 1, 2, 3, and

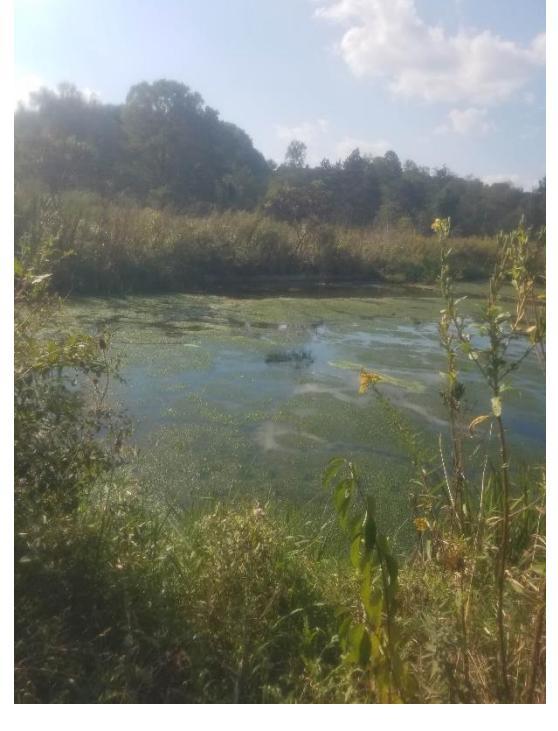
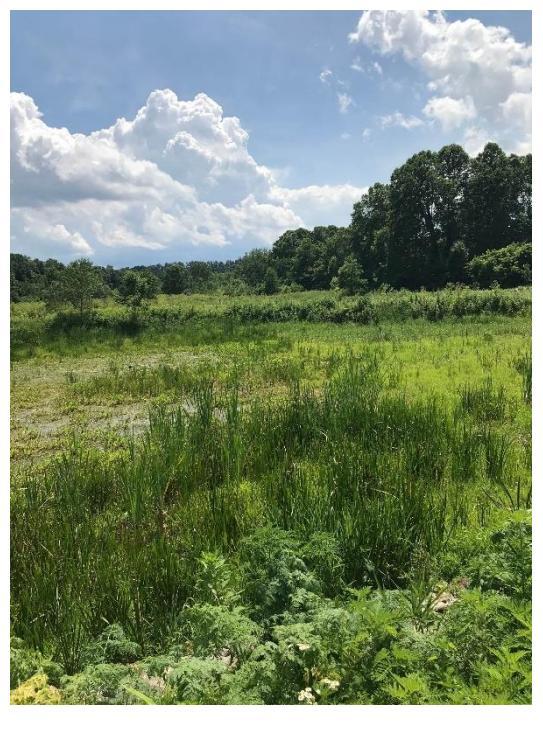
**Figure 10. Pond 5 Before and After System Failure. (A)** Pond 5 photographed before the system's failure shows absence of plant-life. Photo taken 27 September 2017 by Michelle Valkanas, Ph.D. candidate; Duquesne University. **(B)** Pond 5 photographed during the system's repair shows abundance of plant cover in dry ponds. Photo taken 26 June 2019 by Garrett Struble

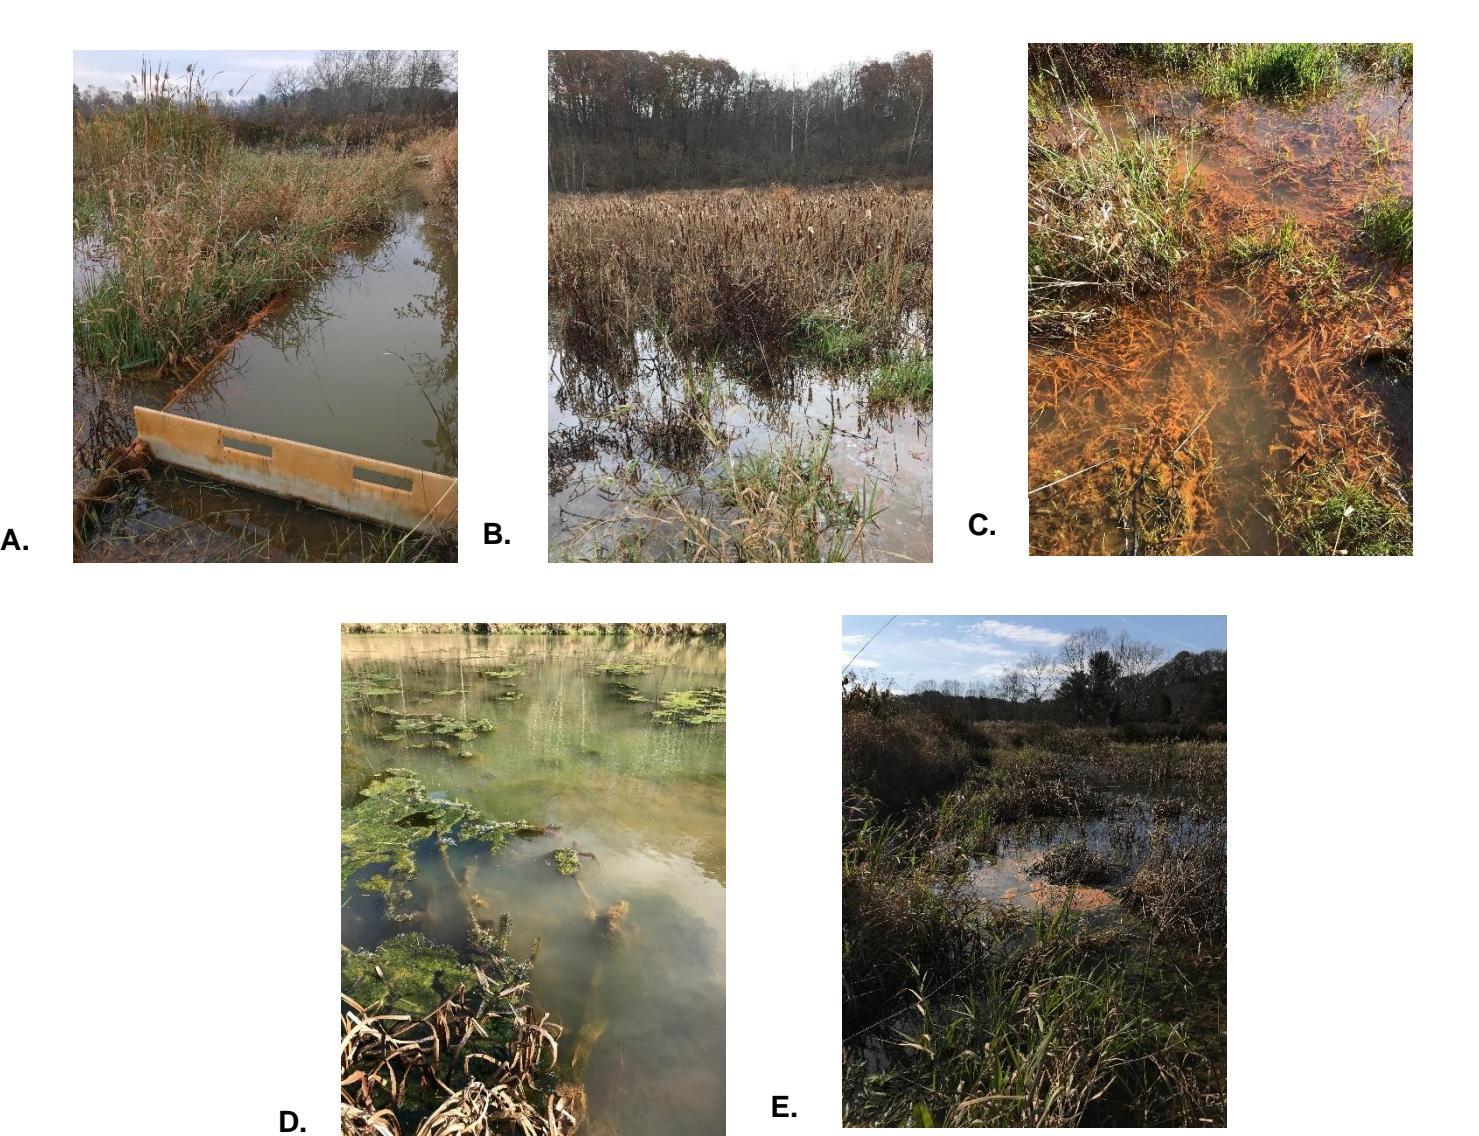
**Figure 11. System Appearance After the Repair. (A)** Vegetation surrounding the influent trough of pond 2. Photo taken 21 November 2019. **(B)** Dense vegetation of *Typha* in pond 3 following repair. Photo taken 21 November 2019 **(C)** Iron plaque on vegetation observed in ponds following repair. Photo taken 10 November 2019 **(D)** Cyanobacteria/algae mat in pond 4 following repair. Photo taken 10 November 2019. **(E)** Dense cluster of grassy vegetation holds iron plaque in pond 5 following repair. Photo taken 10 November 2019.
